## E9X Rear Seat USB-C Charger

*Installation Guide | E90 / E91 / E92 / E93 / M3*

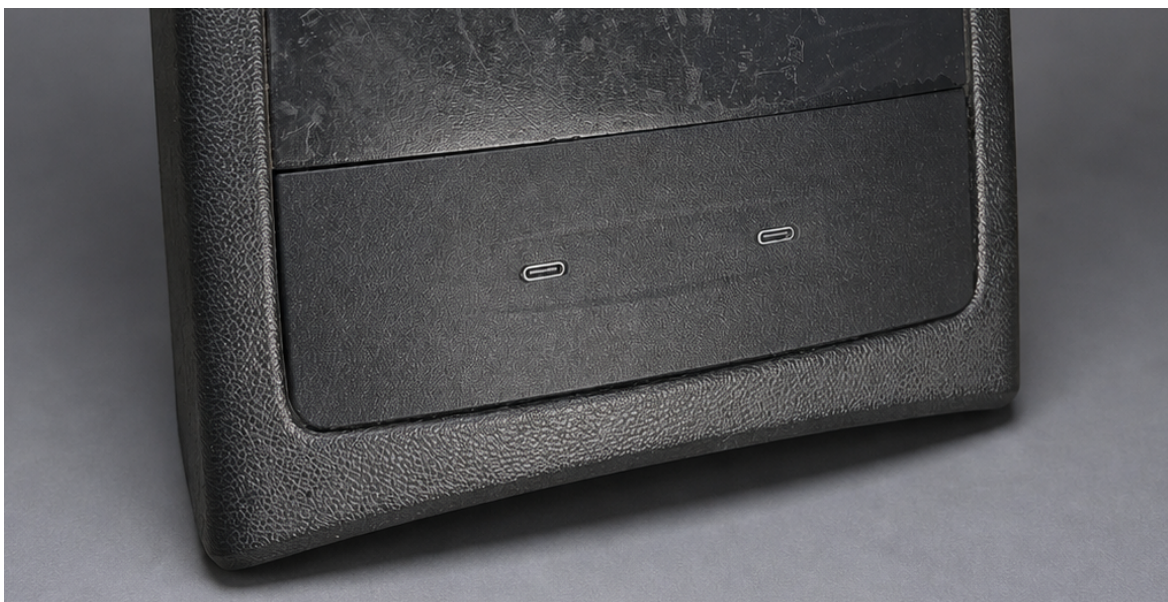
*Finished installation - the dual USB-C module replaces the lower rear-console cubby.*

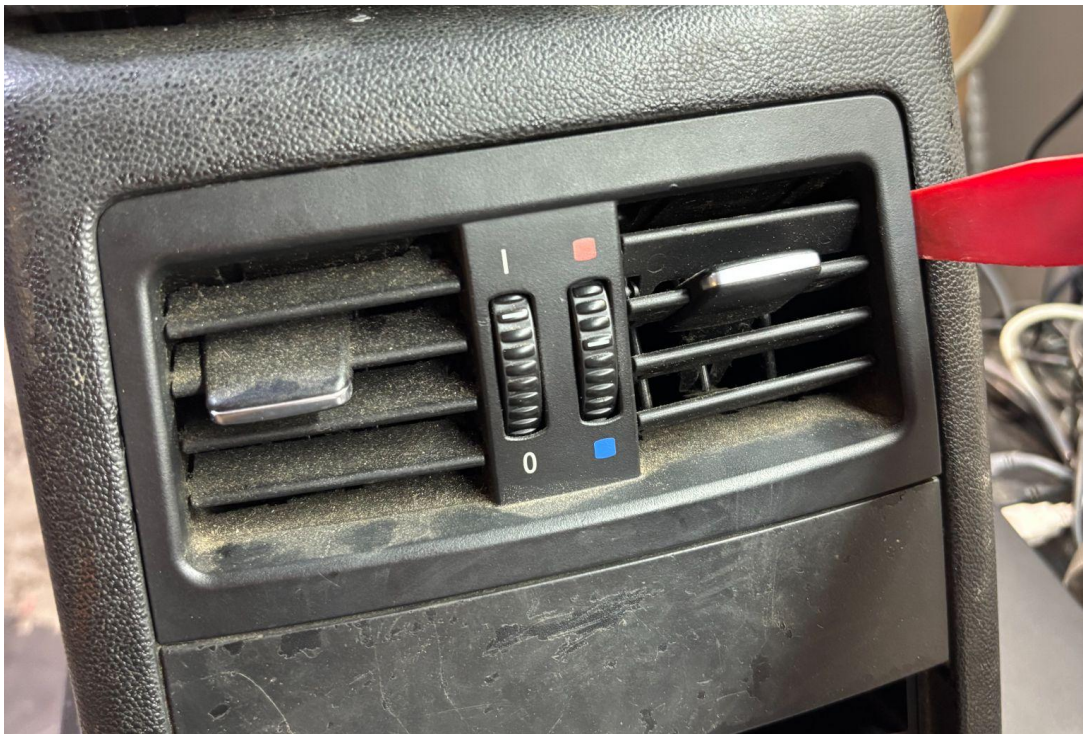
### STEP 2 | REMOVE THE REAR HVAC TRIM

From the rear seat, insert a non-marring trim tool at the outer edge of the rear vent trim. Work around the perimeter and pull the assembly toward the rear seat to release the retaining clips. Pry only on solid trim edges - never on the vent louvers.

*Release the trim gradually to avoid marking the console.*

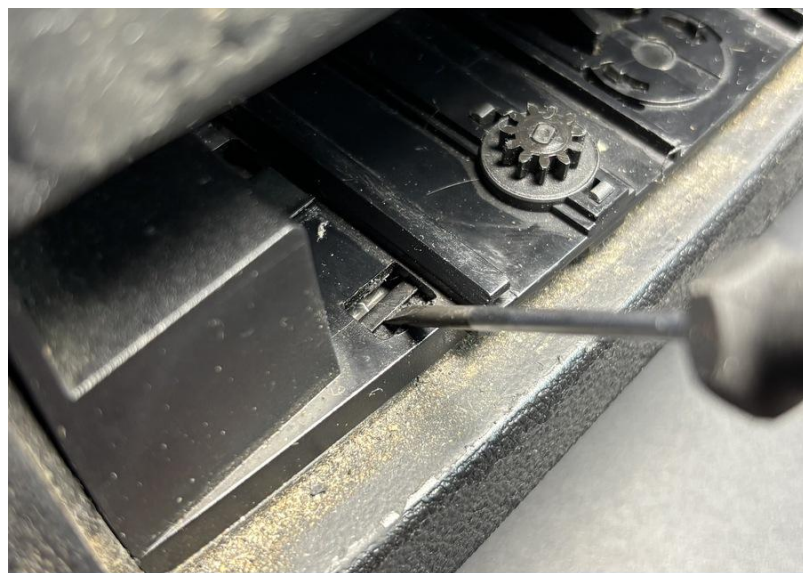
1 LIFT BOTH METAL TABS

Use two picks or small flathead screwdrivers to lift both metal locking tabs at the same time. While holding the tabs up, slide the factory lower cubby toward the rear seat until it clears the console.

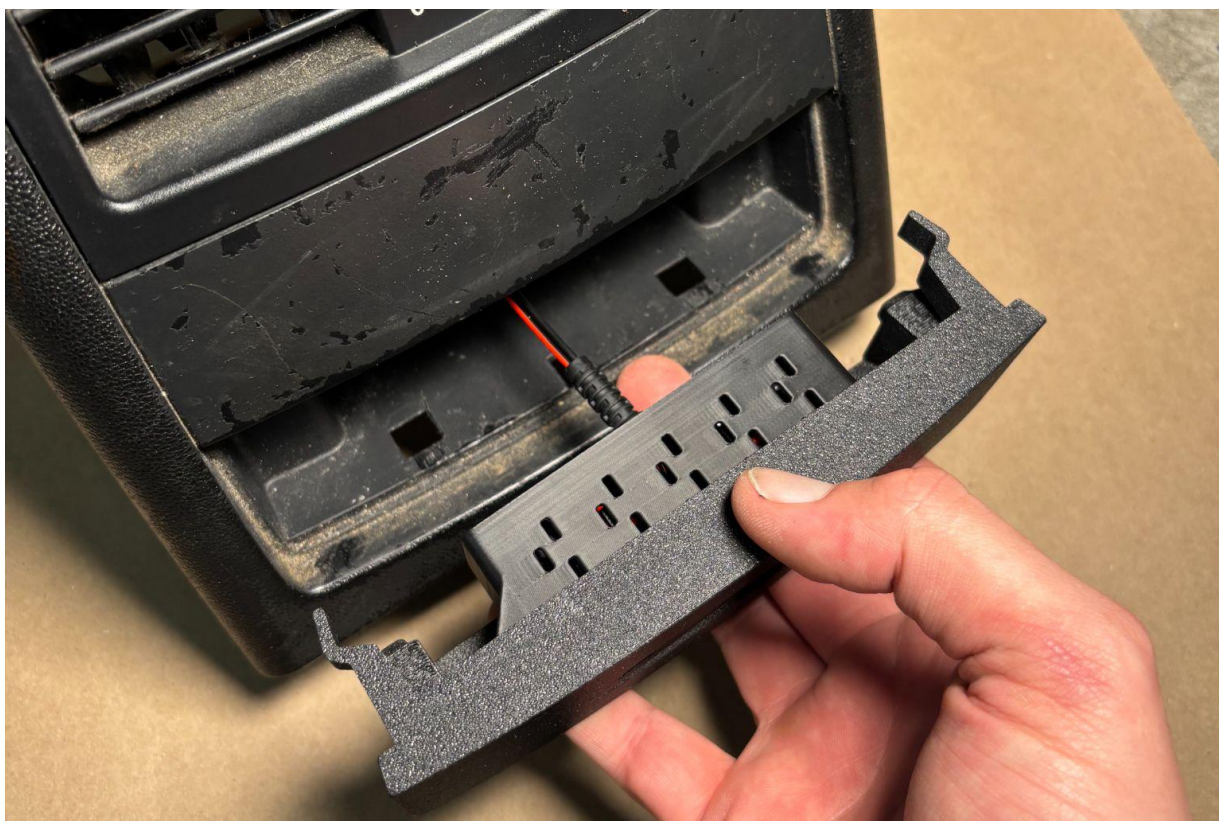
### STEP 5 | SEAT THE USB-C MODULE

Align both retaining tabs with the console slots and press the module inward evenly until both sides lock. The face should sit flush with the surrounding console. If it does not seat easily, stop and reposition the harness behind it.

*Align both side tabs; do not force the module over trapped wiring.*

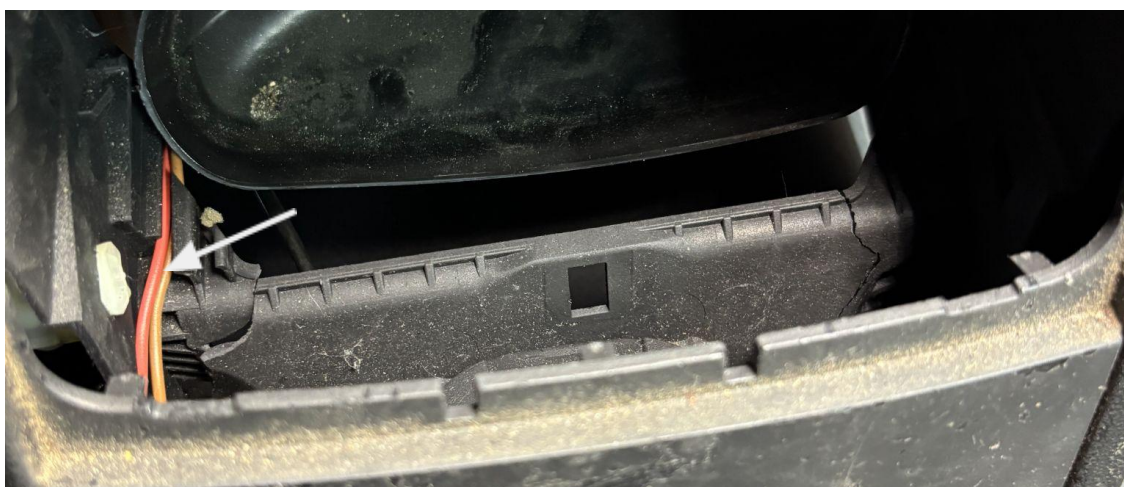
#### STEP 6 | IDENTIFY THE 12V-SOCKET WIRES

Locate the two wires feeding the factory 12V socket under the armrest. On the vehicle pictured, red is +12V and brown is ground. BMW wire colors can vary by year and options; verify polarity using vehicle wiring information or a multimeter before connecting.

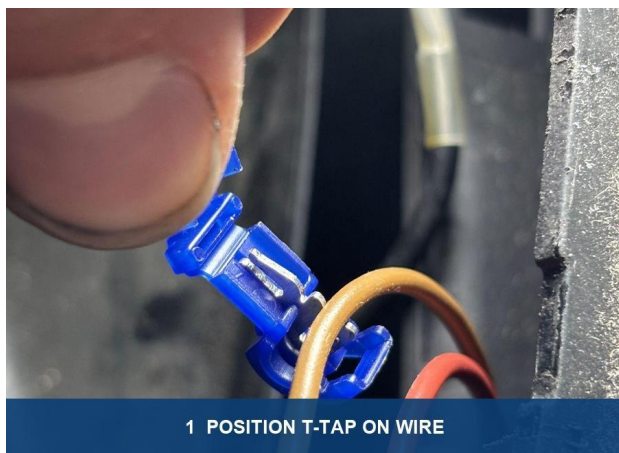
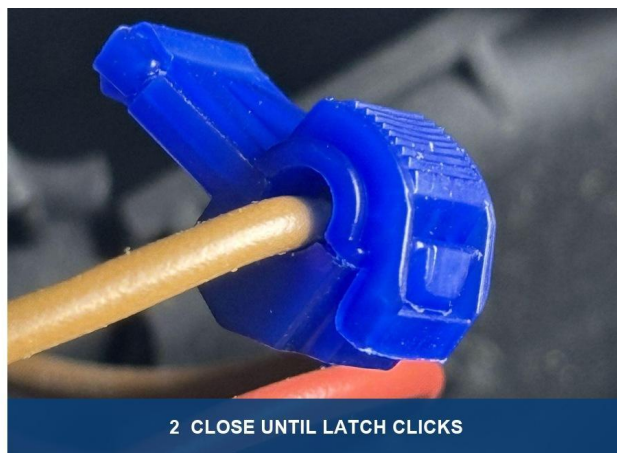
#### STEP 7 | INSTALL THE TWO T-TAPS

Place one blue T-tap around the verified +12V wire and the other around the verified ground wire. Close each clamshell with needle-nose pliers until the latch clicks and the connector is fully seated.

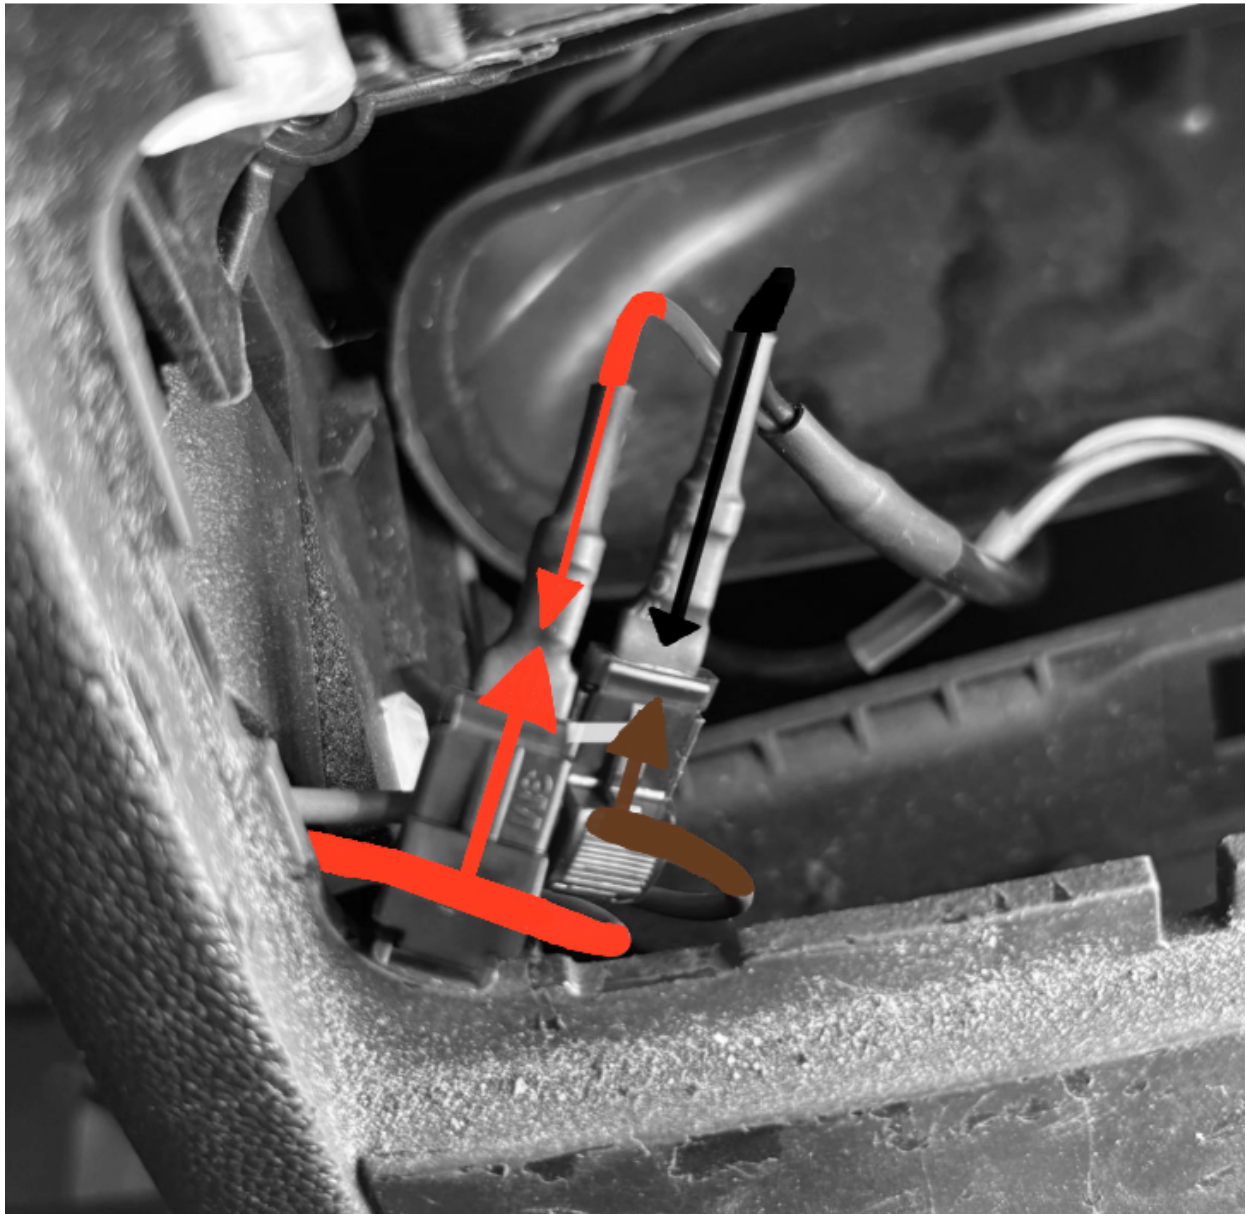
## STEP 8 | CONNECT THE CHARGER HARNESS

Plug the charger harness red lead into the +12V T-tap. Plug the charger harness black lead into the brown (ground) T-tap. Push each terminal on fully and confirm that the two connections cannot contact each other. Verify no exposed metal is showing to avoid shorts.
